CONDITION AND VALUATION SURVEY REPORT

This is to certify that the undersigned surveyor did on December 14, 2011 at the request of Dave Czako for the Naval Surface Warfare Center Dahlgren Division, attend the vessel **SEA LION** to perform a condition and valuation survey. The vessel was seen while hauled at St. Mary's Yachting Center, located in Drayden, Maryland.

Name	Sea Lion
Description	Fiberglass fly bridge convertible
Builder	Ocean Yachts.
Place Built	Egg Harbor, New Jersey
Year	1983
Builders Hull Number	XYU55030M83
Official Number	US Navy 60NS832
Length Overall	<u>58</u> Feet <u>8</u> Inches*
Beam	<u>16</u> Feet <u>4</u> Inches
Draft	<u>4</u> Feet <u>4</u> Inches
Displacement	58,000 lbs
Estimated Market Value	\$ 35,000
Estimated Replacement Value	\$ 1,600,000
Suitability for Intended Service	Poor

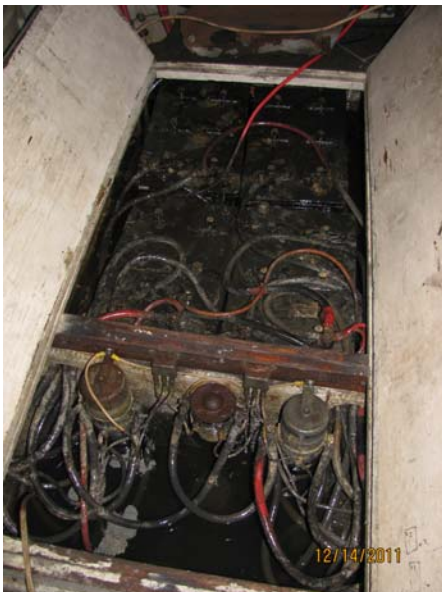
Browned Termination and Melted Sheathing

The DC circuitry is extremely confusing. Much of the wiring is not bundled, there are numerous unidentified wires and loose wire ends, and at least one termination, behind the main panel, which is browned and the associated sheathing melted. This disarray raises the possibility of fire, or the possibility of energized wires going to ground. Additionally, the batteries have been submerged, as have the engine starting solenoids, and many wires were noted as running through the bilge, several of which were very close to the starboard shaft. Efforts should be given to replacing the batteries and solenoids, eliminating any superfluous wiring, switching, and loose wire ends, re-routing the wires in the bilge, and to identifying and bundling the wires in a manner acceptable to common marine practice. The generator starting battery is crowded with an excessive number of battery terminations, which can result in a lack of continuity and an increase of resistance. Efforts should be taken to reduce the number of terminations through the installation of a buss bar. Given the number of deficiencies, it is the opinion of this office that the DC system should not be used until these recommendations are met.
